[Docket No. FAA-2020-0098; Product Identifier 2020-NM-011-AD; Amendment 39-19844; AD 2020-03-20]

Airworthiness Directives; The Boeing Company Airplanes

SUMMARY: The FAA is adopting a new airworthiness directive (AD) for certain The Boeing Company Model MD-11, MD-11F, and 717-200 airplanes, all Model 737-8 and 737-9 airplanes, all Model 737-600, -700, -700C, -800, -900, and -900ER series airplanes, certain Model 747-400 and 747-400F series airplanes, certain Model 757 and 767 airplanes, and all Model 777 airplanes. This AD requires revising the existing airplane flight manual (AFM) to include a limitation to prohibit operations that require less than 0.3 required navigational performance (RNP) within a specified area for airplanes having a certain multi-mode receiver (MMR) with certain software installed. This AD was prompted by reports of the loss of global positioning system (GPS) data or degraded GPS positional accuracy while using a certain MMR. The FAA is issuing this AD to address the unsafe condition on these products.

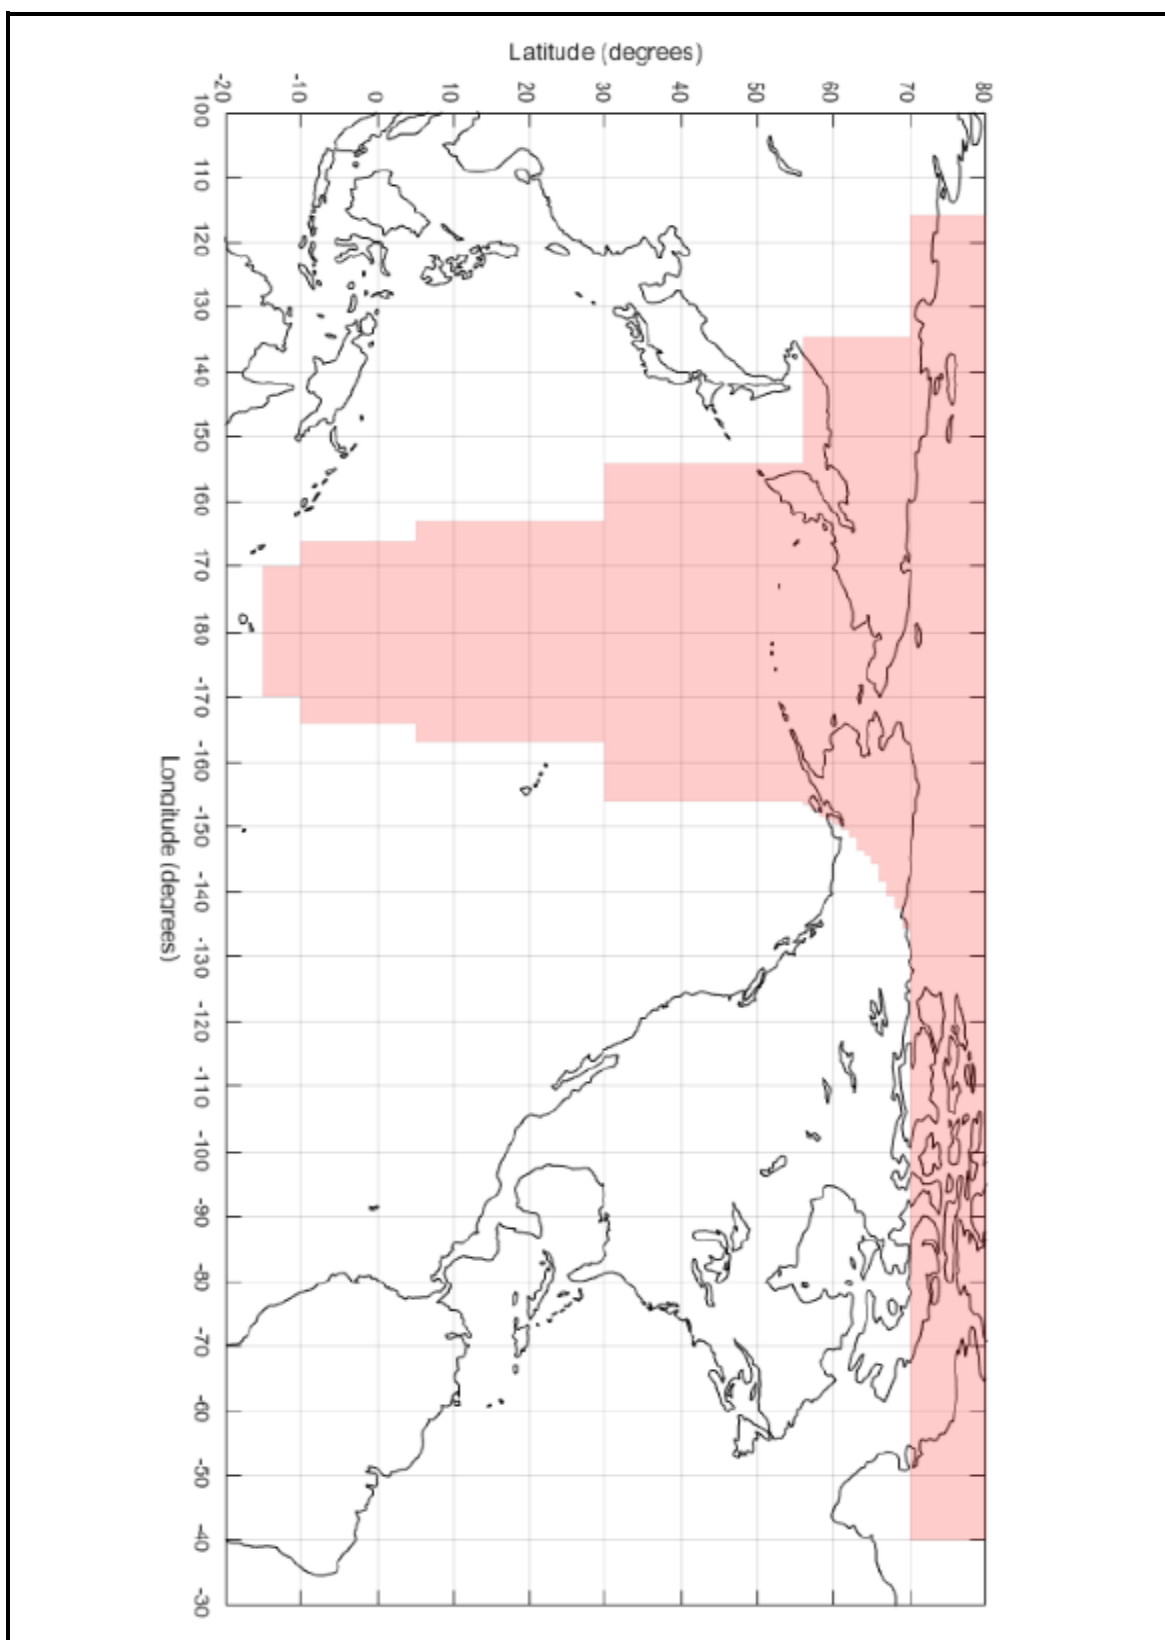
Figure 2 to paragraph (g) – AFM – Limitations or Certificate Limitations continued

Operations that require less than 0.3 RNP (For example, 0.1, 0.11, 0.15, etc.) in the region identified below are prohibited with GLU-2100 OPS software number COL4D-0087-0002, COL4E-0087-0001, COL48-0087-0700, or COL49-0087-0701 installed.

Region bounded by the following coordinates:

Exception: Anchorage (PANC) approach procedures that allow less than RNP 0.3 are authorized provided the instructions outlined in the Electronics – Global Landing Unit Section of Normal Procedures Chapter are followed.
